# Advisory Wire

| REFERENCE NO: | AW700-28-0862 | INFORMATION TYPE: | Maintenance |
| ATA: | 28-40 | EFFECTIVITY: | Global 7500 |
| SUBJECT: | <b>Aft Fuel Tank High Level Sensor</b> | | |

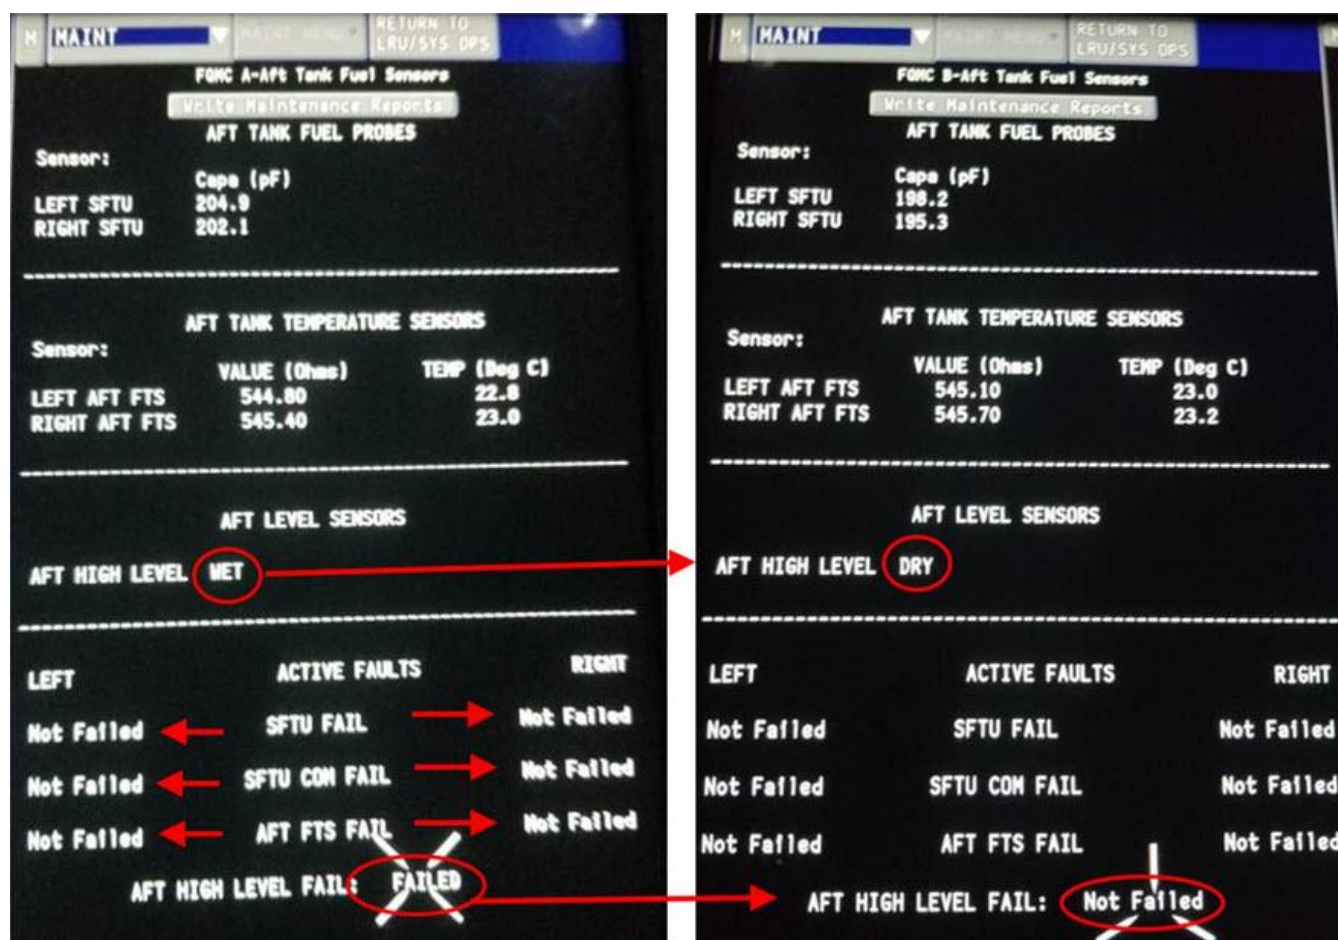
Figure 1 OMS Fuel Data page

Following the complete refueling of the aft tank (Ref. 1.1), the Fuel Quantity Management Computer (FQMC) may interpret a disagreement between the Smart Fuel Tank Unit (SFTU) High Level Sensor (HLS) state and the SFTU fuel height. The FQMC would read the HLS state as immersed (“WET”), and the fuel height measured by the SFTUs would be considered lower than expected. This is due to the normal variation of different jet fuel characteristics. If this occurs, the FQMC may consider the SFTU HLS as faulty and post the following OMS fault:

The fault clears when the HLS state changes from “WET” to “DRY” with the normal decrease of fuel quantity (≈100 lbs) in the aft tank through manual or auto transfer.

This nuisance OMS message does not impact the refueling function and can be validated with the fuel OMS data page (Ref. 1.2) as shown in Figure 1.

HLS failed with full aft tank

Aft fuel tank quantity decreased by 100 lbs

- 1) Ensure that there is no related aft tank refueling system malfunction (i.e., aft tank can be fully refueled).
- 2) Verify in the OMS fuel data page that the aft HLS state is shown as “WET” and that the aft tank fuel quantity is full. (Ref. 1.2 & Figure 1)
- 3) The fault resets when the aft tank quantity is decreased sufficiently ( $\approx 100$  lbs) to change the HLS state from “WET” to “DRY”.

This fault shall be considered a nuisance message only if the message is cleared as per step 3 above. Otherwise, the message should not be considered a nuisance and be troubleshoot.
