# Advisory Wire

| REFERENCE NO: | AW700-24-0728 Rev 1 | INFORMATION TYPE: | Maintenance Operational |
| ATA: | 24-26 | EFFECTIVITY: | Global 7500 aircraft (70006 – 70071) |
| SUBJECT: | <b>Dual Frequency Converter Unit (DFCU) Nuisance Messages</b> | | |

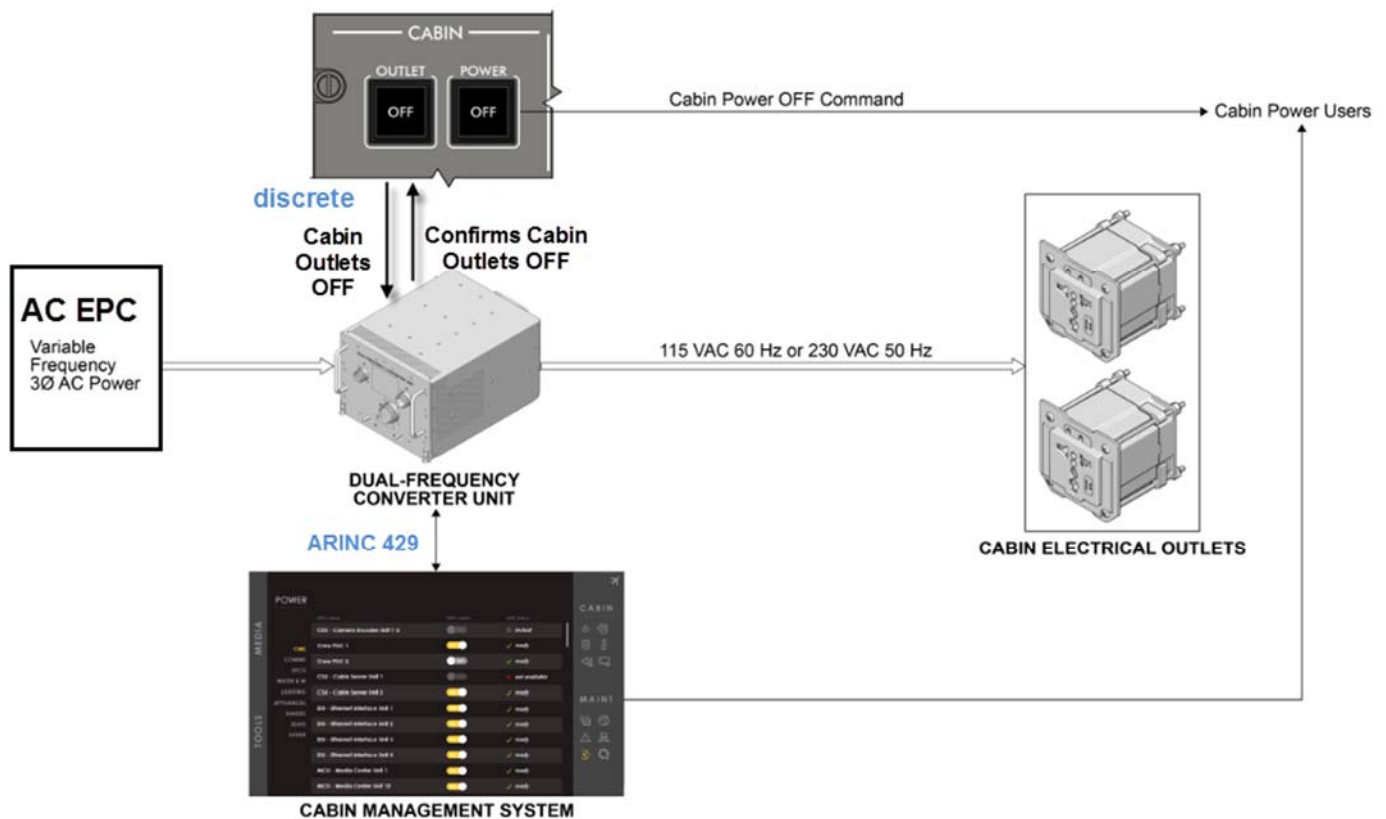
Figure 1

The DFCU communicates with the Cabin Management System (CMS) to control the DFCU outputs and obtains status information from the CMS. The information is visible through the GCP (Fig 1) when faults are detected.

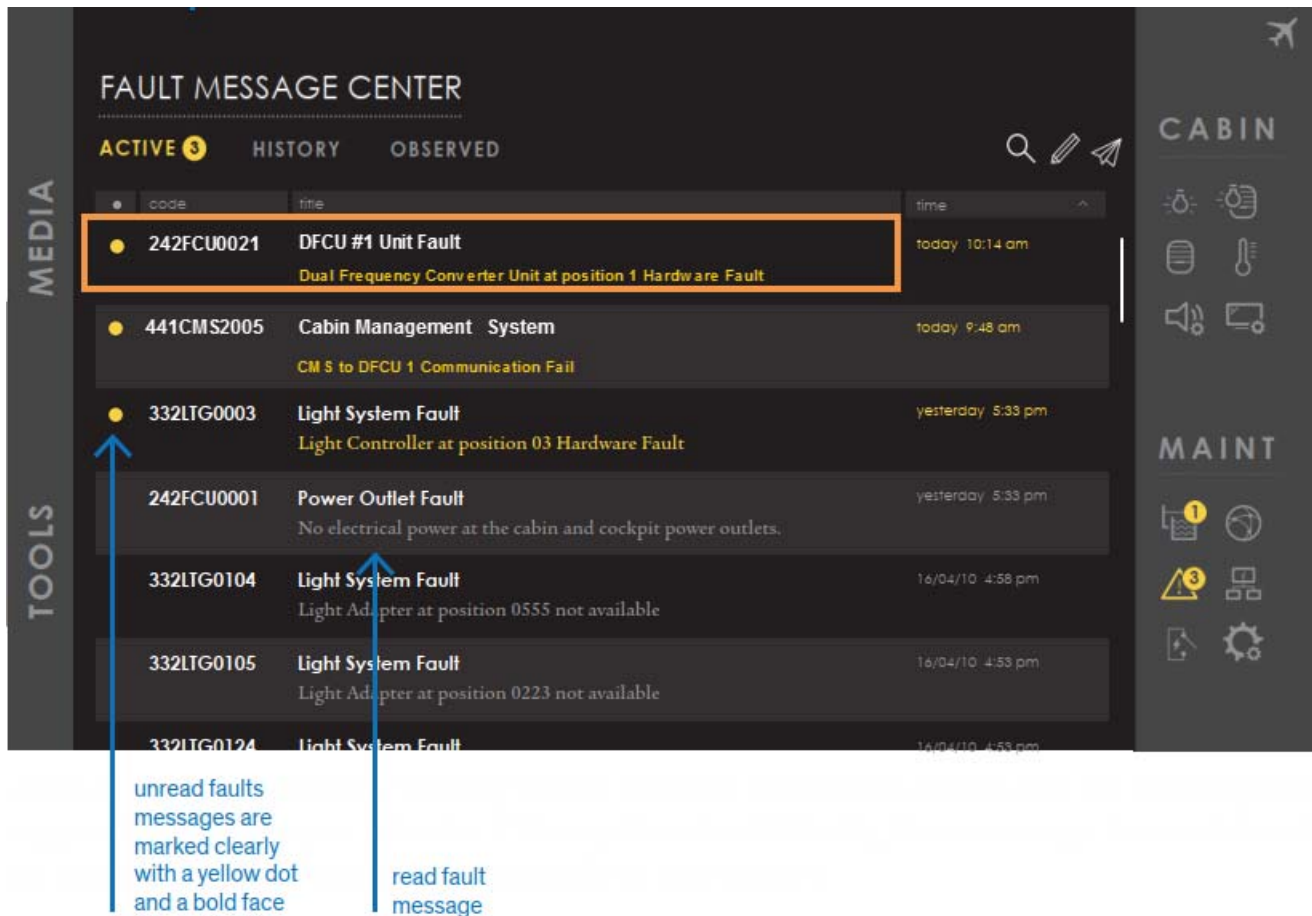
Figure 2

Aircrew and Maintenance personnel should be aware that when the CABIN OUTLET PBA is pushed in, some DFCU may report a nuisance fault to the CMS.

In that case, an active fault "*DFCU # X fault*" (X being "1" or "2") will be posted in the Fault Message Center (FMC) on GCP (Fig 2).

As initially communicated in the SIL0027 (Ref 1.1) the system functionality is not affected. Indeed, to prevent unnecessary troubleshooting time or parts replacement, when the CABIN OUTLET PBA is latched in and a DFCU fault is posted, operator should verify that flight deck outlets are still energized and if so, should ignore this fault. The DFCU fault clears once the CABIN OUTLET PBA is latched out.

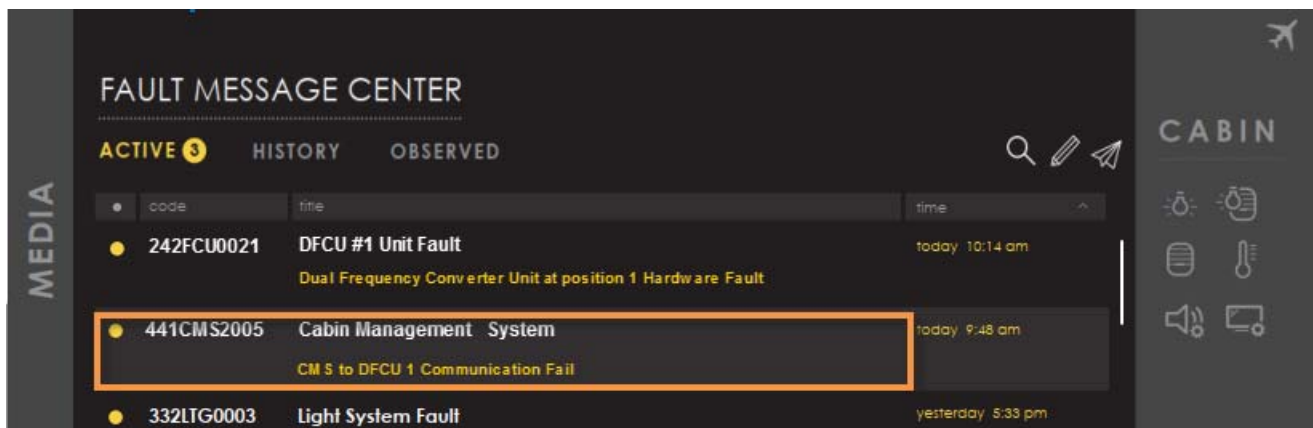
Figure 3

Bombardier is also aware that on some rare occurrences the GCP is not reporting all the DFCU information like the serial, part and software numbers due to ARINC429 communication failure with the CMS (Fig 3).

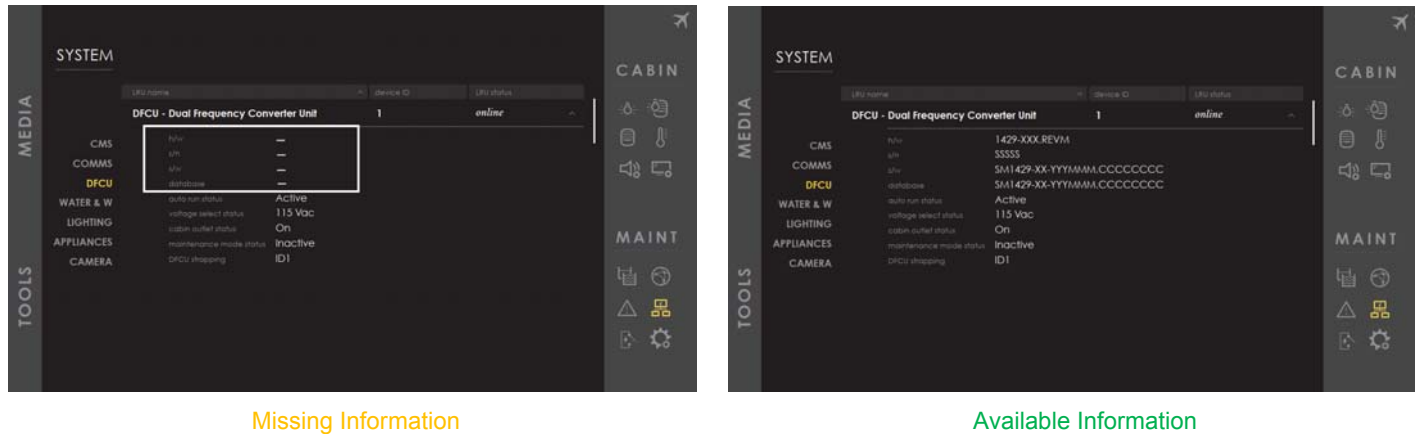
Figure 4

It has been verified that both DFCU functionality and operation are not affected by this loss of information. (Fig 4)

Bombardier is still working with Astronics and the CMS supplier Lufthansa Technik, to address the ARINC429 communication failure (Fig. 4), which does not affect DFCU operation and functionality. This AW will be updated as soon as the technical solution is available.
