# Advisory Wire

| REFERENCE NO: | AW700-25-0774 | INFORMATION TYPE: | Maintenance Operational |
| ATA: | 25-23 | EFFECTIVITY: | Global 7500 Aircraft (70006 - 79999) |
| SUBJECT: | <b>Sliding Door – Restoration of Normal Operation Following Use of Manual Override</b> | | |

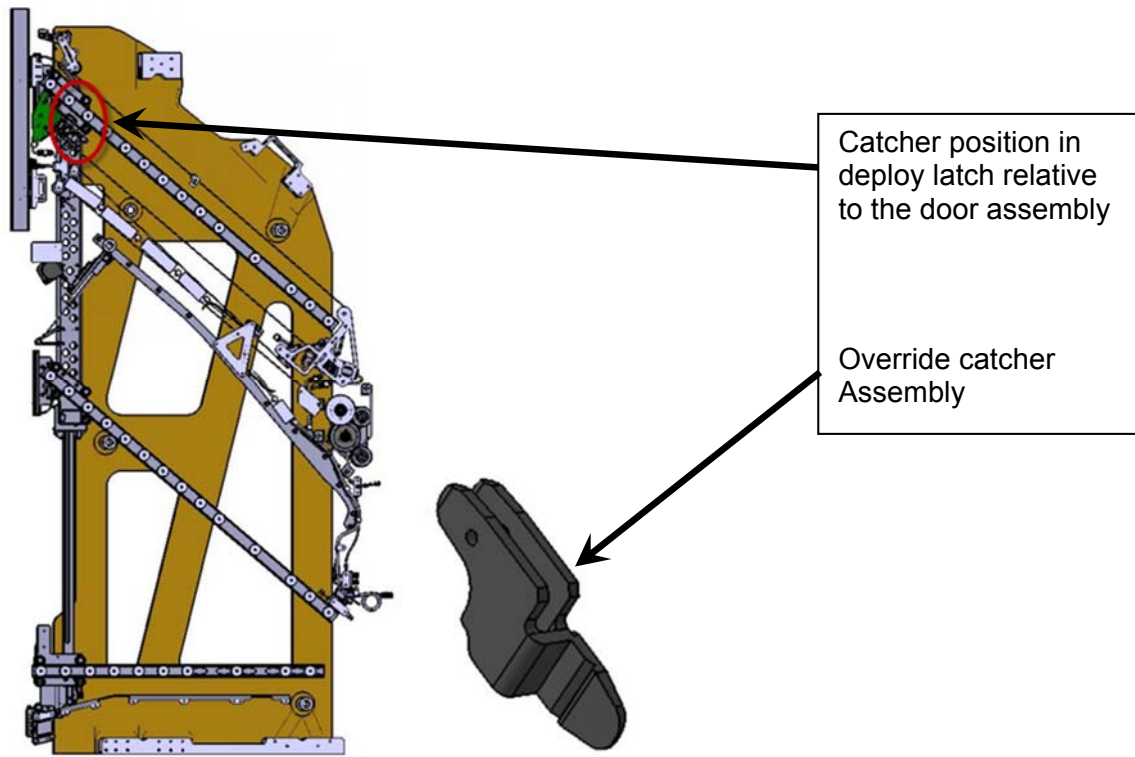
Figure 1 – Catcher Assembly

Manually sliding the door open disengages the catcher assembly (Figure 1) from the door mechanism. The catcher remains in the latched position (Figure 2) while the door stows, which prevents the sliding door from operating normally:

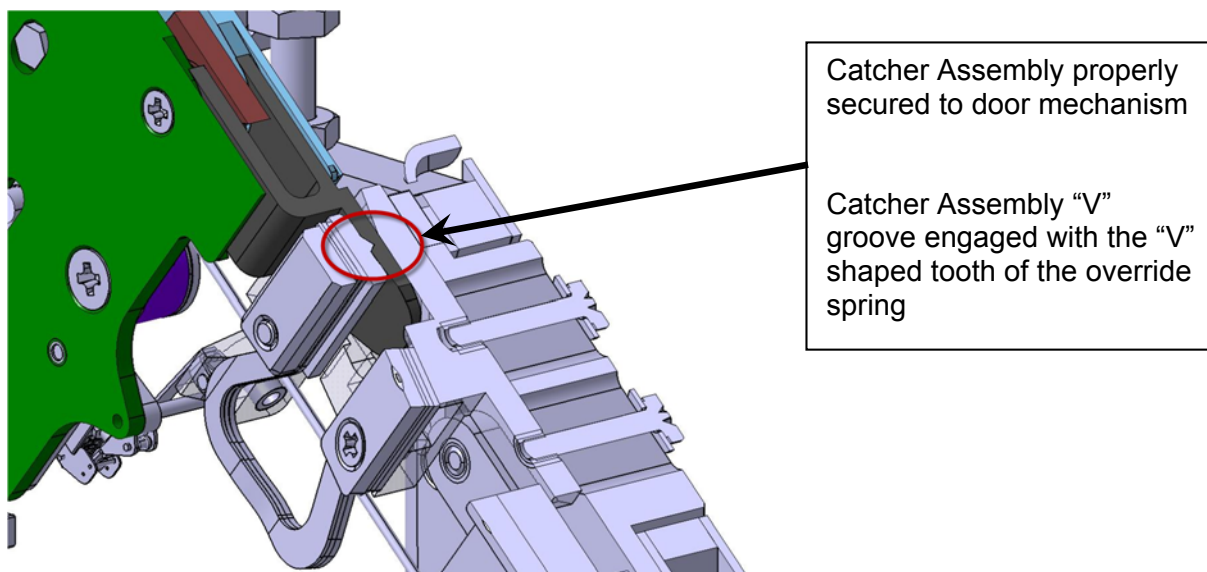
Figure 3 – Catcher Assembly Secured to Door Mechanism with Door Shown Latched Properly in Fully Deployed Position

- When the manual override is used, the door will subsequently release from the fully stowed position properly, but the override catcher assembly needs to be re-engaged (Figure 3) for the door to properly latch in the fully deployed position.
- If the override catcher assembly does not properly re-engage when the door is deployed, the door will not latch securely in the fully deployed position and it can stow unexpectedly.

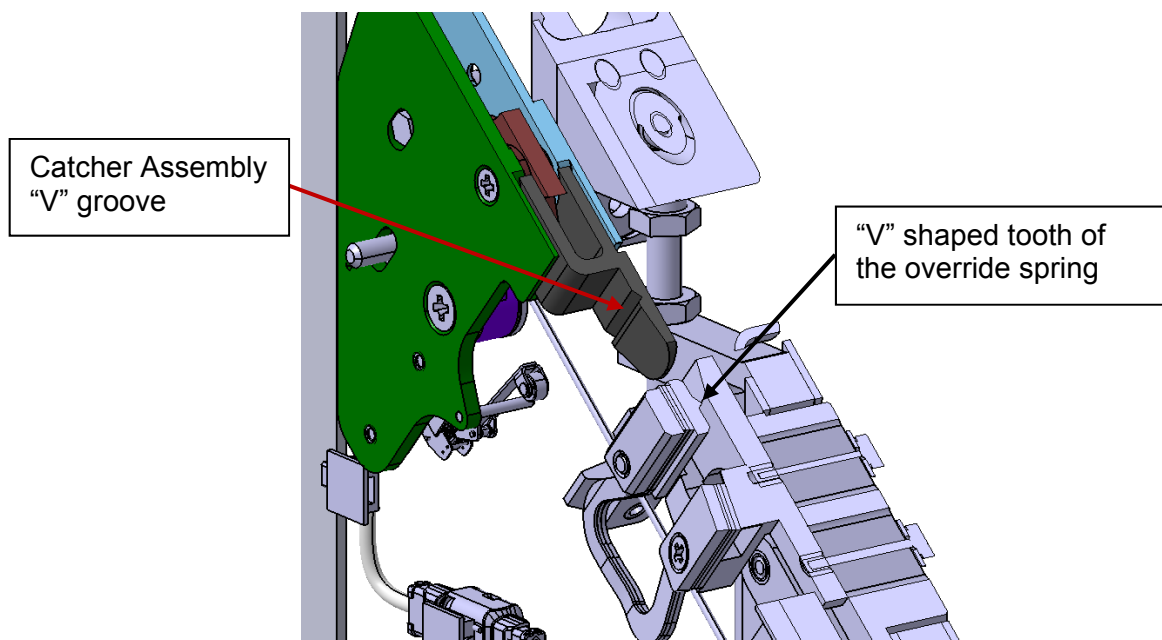
Figure 4 – Catcher Assembly Not Engaged with Override Spring with Door Shown Approximately 1 inch (2.5 cm) from Fully Deployed Position

1. Press the door button to deploy the door and pull it out of the pocket until it is 1 inch (2.5 cm) from the fully deployed position
2. Firmly push the door to the fully deployed position with a force of approximately 25 pounds and verify that the catcher assembly re-engages the override spring (Figure 4):
  - a. A loud “Click” from the location of the door mechanism (Figure 5) indicates that the catcher assembly has re-engaged the override spring.
3. Operate the door normally for one complete cycle (stow and then deploy the door using the door button) and then verify engagement of the catcher assembly with the override spring by trying to stow the door without using the door switch:
  - a. Use the handle to push the door into the pocket with a force of not more than 15 pounds.
  - b. If the door remains fully deployed, normal operation has been restored.
