**UNITED STATES AIR FORCE**  
**AIRCRAFT ACCIDENT INVESTIGATION**  
**BOARD REPORT**

**E-11A, T/N 11-9358**

**DATE OF ACCIDENT: 27 JANUARY 2020**

**SUMMARY OF FACTS AND STATEMENT OF OPINION**  
**E-11A, T/N 11-9358**  
**27 JANUARY 2020**

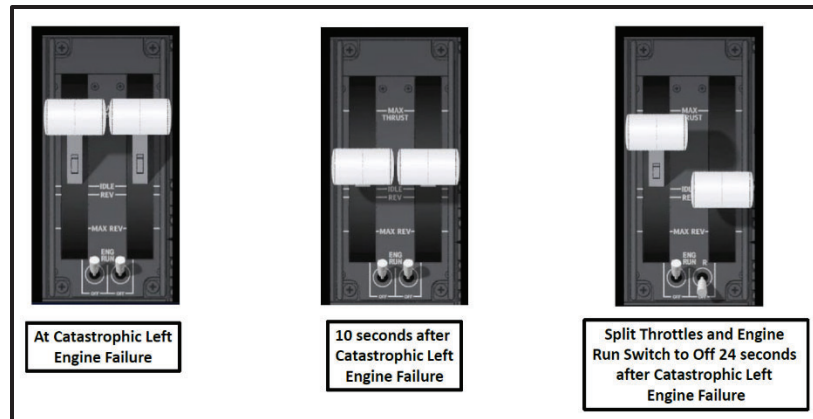
**Tab Z-12 (Simulated)**

Ten seconds after the catastrophic left engine failure, the MC retarded both throttles to just less than halfway (14 degrees; total throttle range is from 0 – 40 degrees) for one second, then slightly advancing the left throttle separately (26 degrees) for one second, then retarding it to align with the right throttle (both at 16 degrees) for one second, and finally splitting the throttles to advance the left throttle (to 31 degrees) while retarding the right to idle (0 degrees) (Tab DD-13 to DD-14). Nine seconds after moving the right throttle to idle, the MC placed the right engine run switch to off, shutting down the right engine (Tab DD-15). Finally, at 1251:19L, the left throttle was advanced to full power (40 degrees), briefly cycled then brought to idle (Tab DD-15). At 1251:23L, both throttles were advanced from idle to full power (Tab DD-15).

The first throttle movements may represent an attempt to first reduce vibration by reducing power, then to isolate the affected engine by moving the left throttle separately. Airframe vibrations did dampen slightly, but then resumed, roughly coincident with the power reduction and the advancement of the left throttle at 1251:08 (Tab DD-12 to DD-13). However, the moves were very brief and the vibrations in the left and right and up and down directions were cyclical but not regular (Tab DD-13). In any case, the left engine did not respond – the engine N1 ( fan RPM) had spiked to a maximum value, but other engine instruments continued to roll back consistent with an engine shutdown (Tab DD-13).

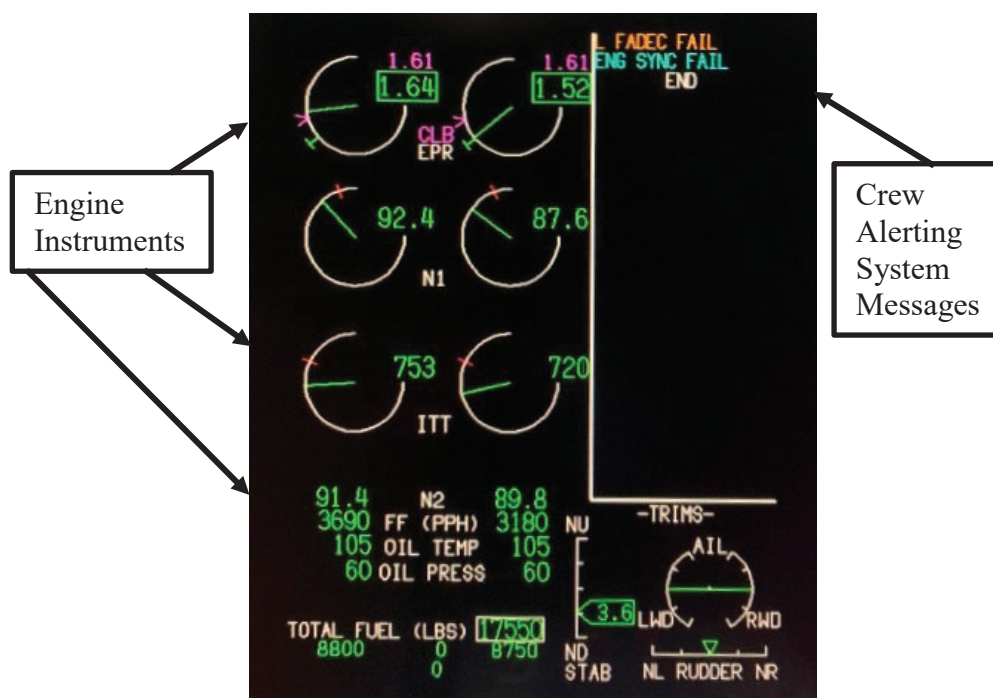
Tab Z-13 (Simulated)

The design of the MA's crew alerting system display and supporting inputs displayed an amber "**L (Left) FADEC FAIL**" caution crew alerting system message, accompanied by the amber Master Caution light at MC eye level (on the cockpit glareshield), derived from the software-directed shutdown of the left engine at 1250:52L (Tab J-179). A large majority of squadron E-11A pilots interviewed understood this message to indicate a failure of the software, but not necessarily to affect the engine in the short term (Tabs V-2.4 to V-2.6, V-3.4, V-7.4 to V-7.5, V-11.5 and V-22.3 to V-22.5). The checklist for "**L FADEC FAIL**" lists three possible consequences of the failure, one of which is eventual engine shutdown (Tab AA-20). The disengagement of the auto-throttles would have caused an audible warning, though the throttles would be expected to, and did, remain in place (Tab J-116 and J-136). Finally, a cyan "**ENG (Engine) SYNC FAIL**" advisory crew alerting system message was displayed (Tab J-179). Collectively, in the first moments, the crew alerting system did not directly indicate the left engine failure (Tab Z-13).

**EICAS Display #1:** A representative image of the crew alerting system messages within 1-2 seconds of the initial event and the left engine's FADEC-directed shutdown (Tab DD-6)

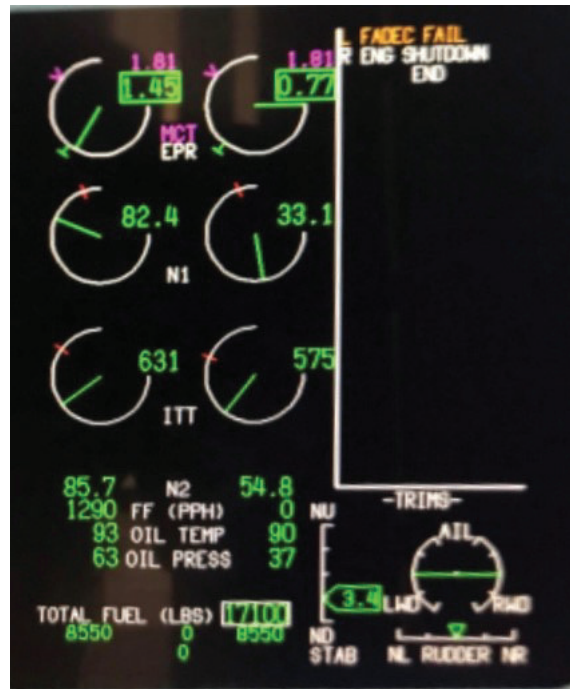
**Tab Z-17 (Simulated)**

When the right engine was shut down at 1251:16L, the crew alerting system would have posted a status crew alerting system message of "**R (Right) ENG SHUTDOWN**," displayed in white and below the other crew alerting system messages (Tabs J-180 and Z-17).

**EICAS Display #2:** A representative image of the crew alerting system messages just after the right engine shutdown.

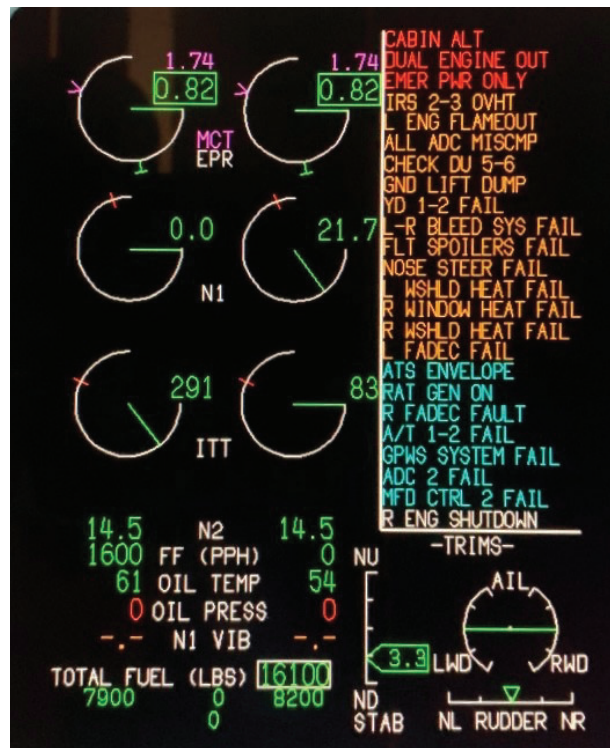
Tab Z-16 (Simulated)

Dual engine failure indications from the crew alerting system occurred later, estimated at 1252L (Tab J-180). The red **"DUAL ENGINE OUT"** warning crew alerting system message indicates that both engines have failed/been shutdown (Tab AA-3). This message is designed to display when both the left and right engines indicate either an amber **"ENG FLAMEOUT"** caution crew alerting system message or white **"ENG SHUTDOWN"** status crew alerting system message (Tab J-180). Thus, rather than displaying immediately when the right engine run switch was placed to off and the left engine had been shut down by the FADEC, the red **"DUAL ENGINE OUT"** warning crew alerting system message and an associated red Master Warning light on the glareshield did not appear until the **"L ENG FLAMEOUT"** was triggered as that engine's internal RPM dropped below 35%, estimated some 30-45 seconds later (in accordance with system logic (Tab J-180 and Z-16)). Note that the flameout caution and dual engine warning would have preceded the red **"CABIN ALT"** (altitude) warning crew alerting system message, and several other systems messages (Tab Z-16 to Z-17).

**EICAS Display #3:** A representative image of cockpit indications following the amber “**L ENG FLAMEOUT**” caution, red “**DUAL ENGINE OUT**” warning, and red “**CABIN ALT**” warning crew alerting system messages with associated systems messages.

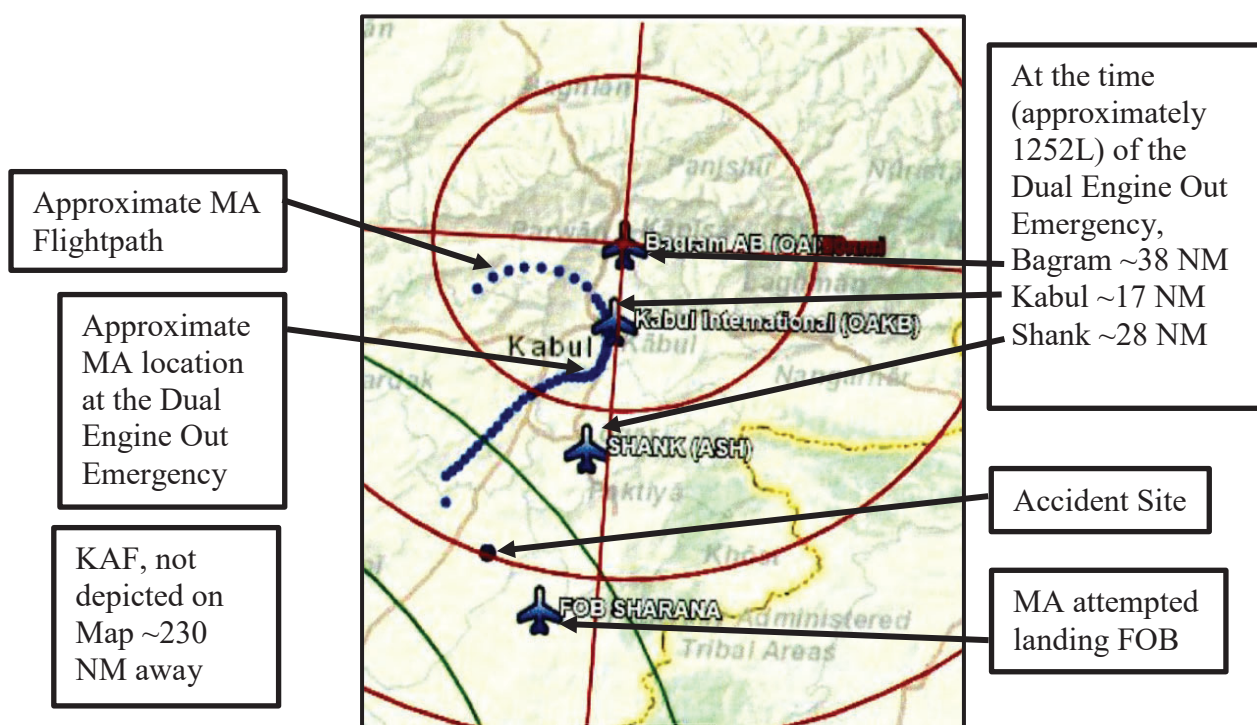
Tab Z-4

Even with the loss of both engines, backup E-11A systems would have allowed the MA to be controlled through an emergency landing. Additionally, both performance data and flight simulation profiles suggest that a divert to another airfield was still possible after the dual engine emergency (Tabs DD-6 to DD-7). However, the probability of a successful dual engine out landing cannot be determined, since it has never happened, and the MC would have had to accomplish a divert procedure not executed for at least several months prior to the mishap (Tab V-26.14). The MC would need to alter the flight plan, accomplish normal, emergency and divert checklists,

initiate communications, and manage their descent and routing to arrive at the divert airfield in a position to land without thrust to correct any miscalculations (Tab AA-37 to AA-42) .

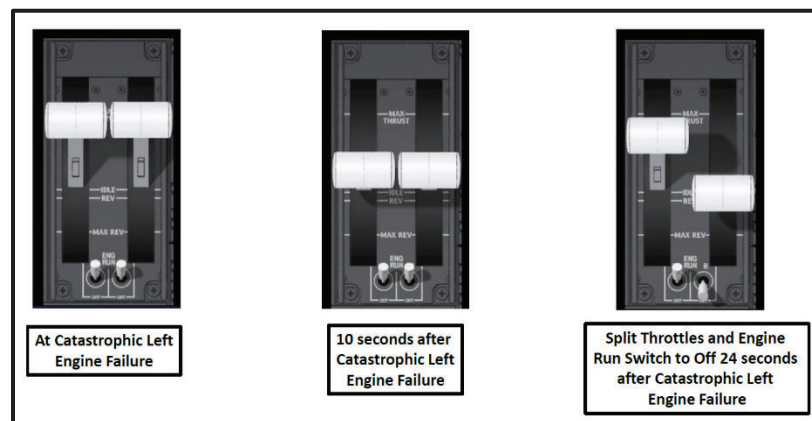
Tab Z-12 (Simulated)

Ten seconds after the catastrophic left engine failure, the MC retarded both throttles to just less than half way (14 degrees; total throttle range is from 0 – 40 degrees) for one second, then slightly advancing the left throttle separately (26 degrees) for one second, then retarding it to align with the right throttle (both at 16 degrees) for one second, and finally splitting the throttles to advance the left throttle (to 31 degrees) while retarding the right to idle (0 degrees). Nine seconds after moving the right throttle to idle, the MC placed the right engine run switch to off (moving the throttle to idle before switching the engine run switch to off is a FCOM checklist procedure when it is a crew initiated engine shutdown), effectively shutting down the right engine. See Figure **Tab Z-12**, which is a representative image of the throttles and engine run switch panel. Because of the minimal time spent in each throttle position, the above throttle movements could not be used reliably to assess engine response.

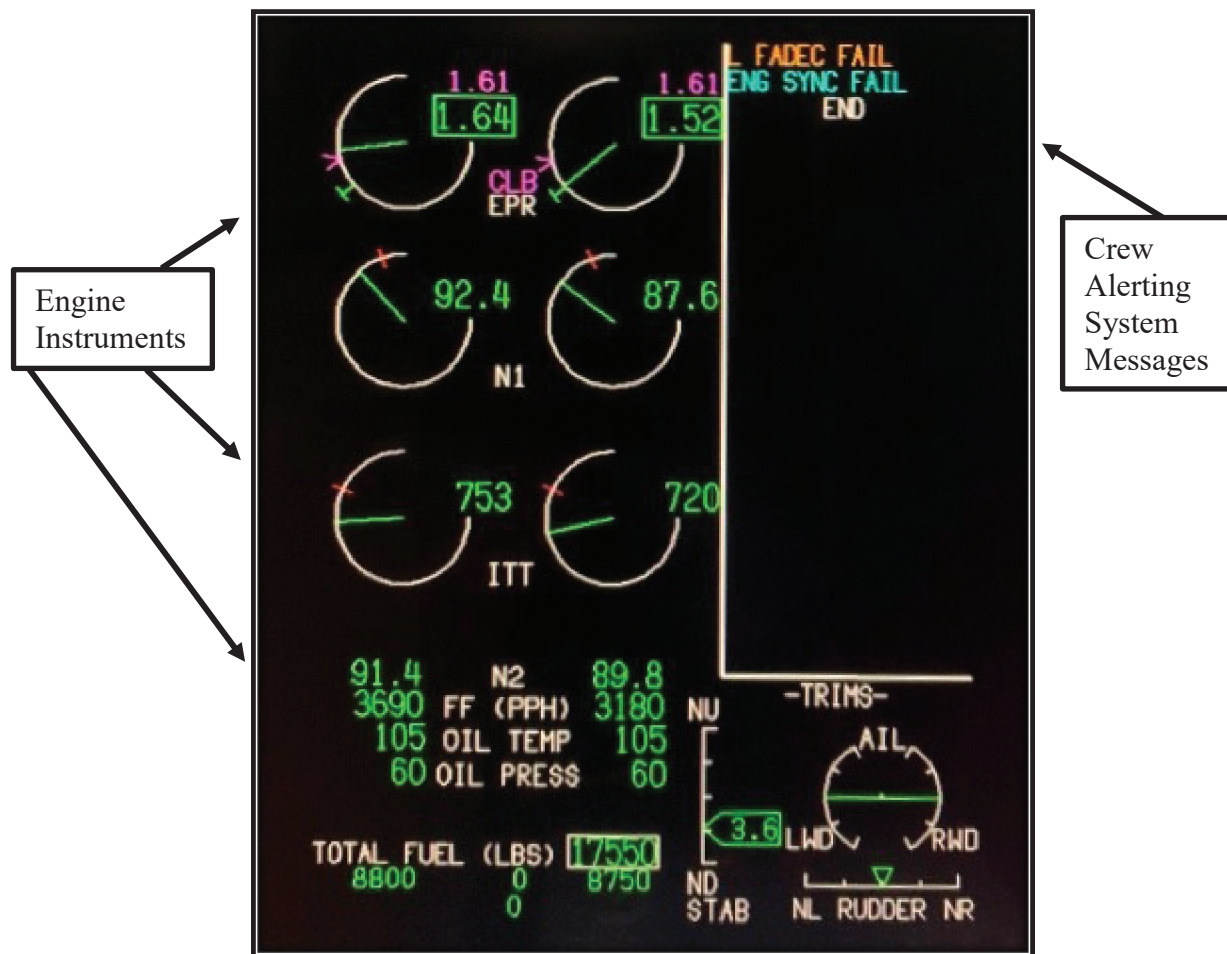
Tab Z-13 (Simulated)

The E-11A's EICAS displayed an amber "**L FADEC FAIL**" caution crew alerting system message with an amber Master Caution light on the glareshield concurrent with the FADEC shutdown of the left engine (a consequence of the L FADEC FAIL message). Figure **Tab Z-13** depicts a representative image of the EICAS display and shows crew alerting system messages 1-2 seconds after the catastrophic left engine failure and the FADEC-directed engine shutdown. Importantly, the engine instruments do not reflect those of the MA and may differ.

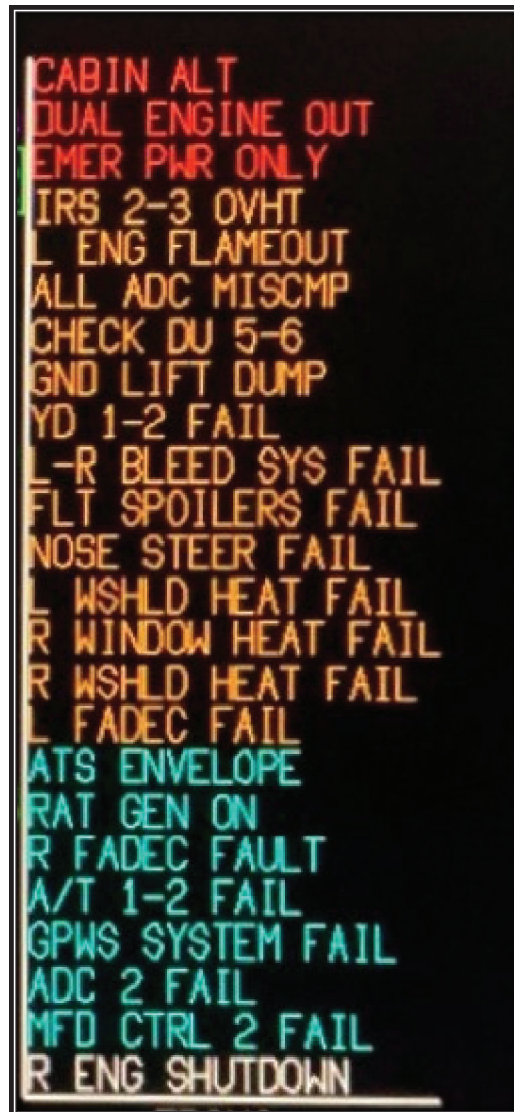
Tab Z-16 (Simulated)

In the first 24 seconds after the catastrophic left engine failure, the EICAS crew alerting system display did not necessarily suggest an engine failure. However, when the MC initiated shutdown of the right engine, it would have triggered an immediate white “**R ENG SHUTDOWN**” status crew alerting system message. Then, once the left engine RPM decreased below 35% (approximately 30 seconds after the right engine shutdown), an amber “**L ENG FLAMEOUT**” caution crew alerting system message would have been displayed followed by a red “**DUAL ENGINE OUT**” warning crew alerting system message, and a red Master Warning light (approximately 1252L). Of note, other EICAS crew alerting system messages would have been displayed, but are not important in this analysis of determining the affected engine. Figure **Tab Z-16** depicts a representative image of the crew alerting system part of the EICAS display and the crew alerting system messages showing the right engine shutdown, dual engine out, and left engine flameout messages indicating a dual engine out emergency.

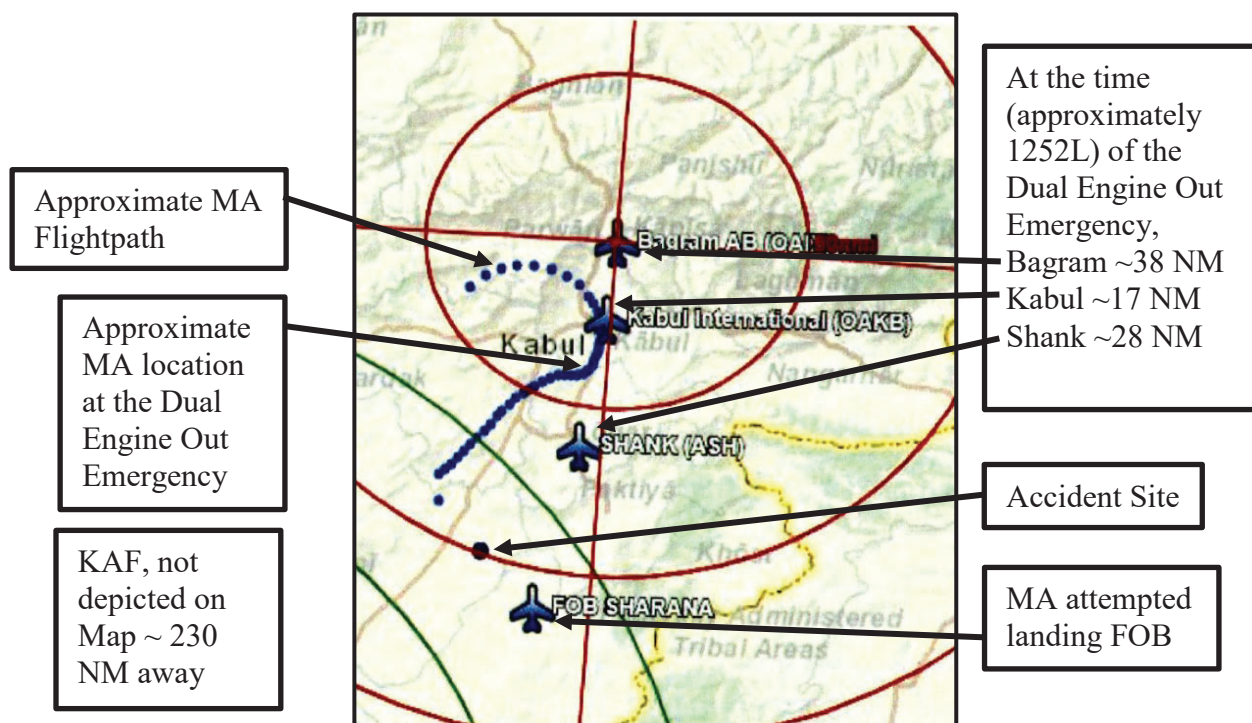
Tab Z-4

Even with the loss of both engines, backup E-11A systems allow the aircraft to be controlled through an emergency landing, and both performance data and flight simulation profiles suggest that a divert to another airfield was still possible even after the dual engine emergency. However, the exact probability of a successful dual engine out landing, since it has never happened, cannot be determined. In fact, the MC would have had to accomplish a procedure only considered hypothetically. During the mishap, the MC would need to alter the flight plan, accomplish checklists, initiate communications, and manage their descent and routing to arrive at the divert airfield in a position to land without the ability to correct any miscalculations.
