# Advisory Wire

REFERENCE NO: AW700-36-0855 Rev. 03

EFFECTIVITY: Global 7500 aircraft

**SUBJECT: Heat Exchanger Rope Seal**

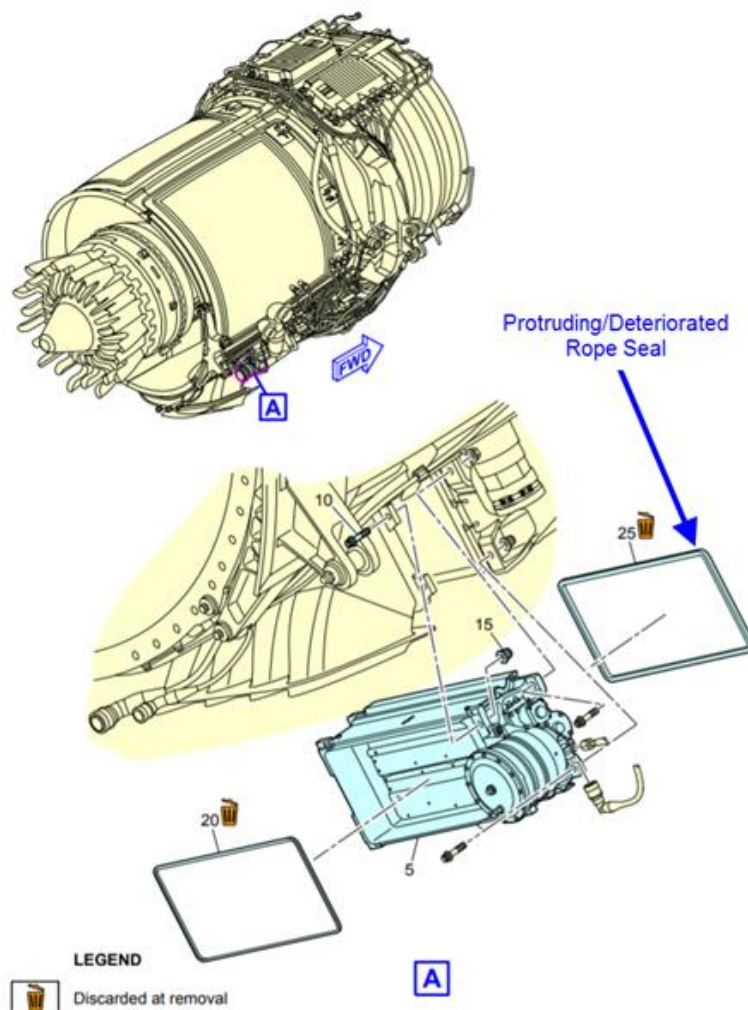
Bombardier has received reports of discoloration found on the inside of the lower engine cowlings. When looking above the area, the rope seal at the PCE / FAV interface was found protruding and damaged.

The damaged rope seal is part number (PN) 70659-30 (Ref 1.1). When replacing the rope seal, the FAV and exhaust will need to be removed to replace the forward seal (Ref 1.2).

Bombardier and the vendor, Liebherr, concluded the investigation and the root cause was identified. It has been determined that the mechanical properties of the rope seal had failed and that a different type of seal was required for this application. Hence, a new seal design was developed and is now available via the SB (Ref 1.4) incorporation.

Bombardier recommends Operators to incorporate the recently released SB 700-36-7505 (Ref 1.4), available on the Bombardier portal. The SB should be incorporated at the earliest convenience in order to prevent collateral damage to the engine cowling, main precooler insulation or other areas surrounding the rope seal.
