# Advisory Wire

REFERENCE NO: AW700-44-0706 Rev 01

EFFECTIVITY: Global 7500 aircraft

**SUBJECT: Ka-Band Sat Ground transmit  
PBA incorrect status**

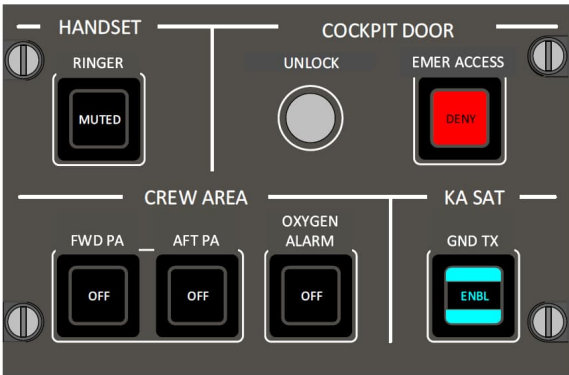
Figure 2: Cockpit KA SAT GND TX PBA illuminated

If this condition occurs, the KA SAT GND TX PBA cyan ENBL will remain illuminated (See Figure 2) and KA SAT GND TX ENBL Advisory CAS message posted. Once this condition is set, even if the PBA is de-pressed, the PBA and associated CAS will not extinguish even if the system is no longer transmitting, resulting in misleading status indication that the system is still transmitting.

Consequently, this may mislead the pilots to lose track of whether the KA-Band system is transmitting or not. Since the KA-Band satellite communication system emits radio frequency energy that is harmful, it must not be enabled on ground when personnel are present in the Antenna Hazardous Exposure Area. (Ref 1.2)

Operators and maintenance personnel should be familiar with the condition described in this AW. Bombardier recommends when pressing the KA SAT GND TX PBA to hold it down for two (2) seconds.

If a short press is accidentally done while on ground, the only way to ensure that the system is not transmitting is to set the KA-Band Circuit Breakers (CB) to OUT as bellow:

This issue can be resolved with the incorporation of the recommended SB700-34-7518 (Ref 1.1). This SB introduces a change to the EICAS Logic Software upgrade via avionics suite software upgrade 2.2. The operators that have not already complied with the Service Bulletin (Ref 1.1), can now communicate with the Bombardier In-Service Implementation Team (ISIT) to schedule its incorporation.
