# Advisory Wire

REFERENCE NO: AW700-36-0825, Rev.3

EFFECTIVITY: Global 7500

SUBJECT: **Kidde Bleed Leak Detection  
Loops Notice of Escape**

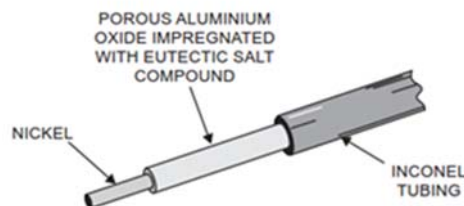
LDL elements contain thermo-resistive eutectic salt compounds embedded between an inner conductor and an outer casing. A local temperature increase causes the salt compound to become conductive resulting in a resistance drop between the inner conductor and outer casing which subsequently sets off the appropriate cockpit warnings.

Due to a manufacturing process error, some LDL elements may not be fully filled with eutectic salt compound and this would result in the LDL elements being unable to detect a hot bleed air leakage.

Bombardier has released a SB (Ref. 1.9) to test and replace any defective LDL elements on the affected aircraft. These SBs are mandated by the ADs (Ref. 1.10 and 1.11) within 3500 flight-hours or 120 months, whichever comes first, from the AD effective date of March 23, 2023. It is recommended, when possible, that the incorporation of the SB be planned during a scheduled maintenance event as described in the SB.
