# Advisory Wire

| REFERENCE NO: | AW700-33-0842 | INFORMATION TYPE: | Maintenance |
| ATA: | 33-41 | EFFECTIVITY: | Global 7500 |
| SUBJECT: | Wing Landing/Taxi Light Lens | | |

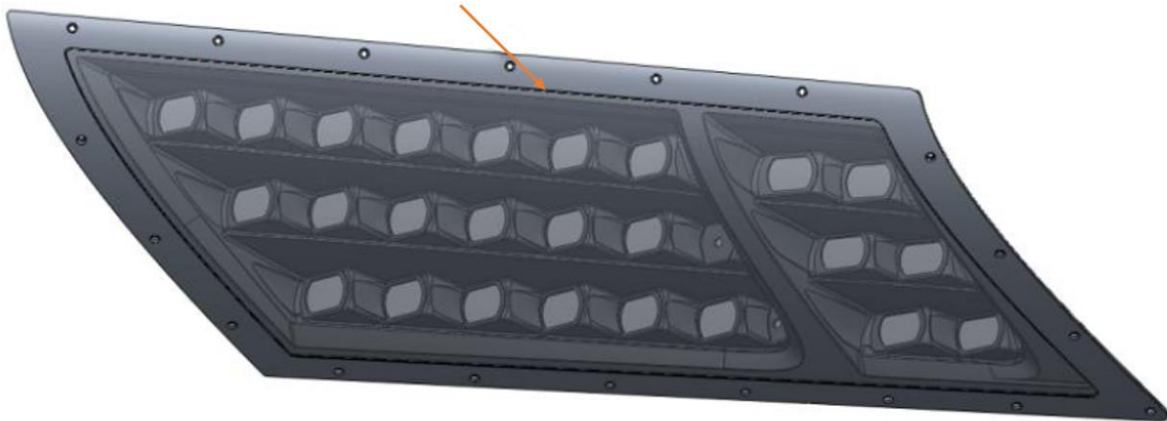
Figure 3: Bezel / Lens Interface

Bombardier has received reports where a disbonding condition was observed at the aluminum bezel and polycarbonate lens interface (Figure 3). This condition, if not identified on the ground during the maintenance or pre-flight walkaround (Ref. 1.2), could result in water ingress into the wing landing light enclosure. In certain instances, this condition has led to a lens detachment from the aircraft in-flight.

To minimize the risk of occurrence of the condition described above, Bombardier recommends operators pay special attention to the bezel/lens interface during the walkaround procedure (Ref. 1.2) and to incorporate the IS Modsum IS700-33-7001 (Ref. 1.3) at the next maintenance opportunity. This IS Modsum provides instructions to apply a layer of protective tape on the WLL lens to prevent erosion at the bezel/lens interface.

Should there be evidence of bezel/lens interface not properly sealed or bonded, Bombardier has issued two temporary General Repair Engineering Order (GREGO) 700-33-41-7002 (Ref. 1.4) and 700-33-41-7003 (Ref. 1.5) to provide temporary bezel/lens interface re-bonding or tape application instructions to allow continued operation until a replacement of the lens is carried out.
