# Aviation Investigation Preliminary Report

| <b>Location:</b> | Houston, TX | <b>Accident Number:</b> | DCA24FA017 |
| <b>Date &amp; Time:</b> | October 24, 2023, 15:20 Local | <b>Registration:</b> | N510HM (A1);<br>N269AA (A2) |
| <b>Aircraft:</b> | TEXTRON AVIATION INC 510 (A1);<br>RAYTHEON AIRCRAFT COMPANY<br>HAWKER 850XP (A2) | <b>Injuries:</b> | 4 None (A1); 3 None<br>(A2) |

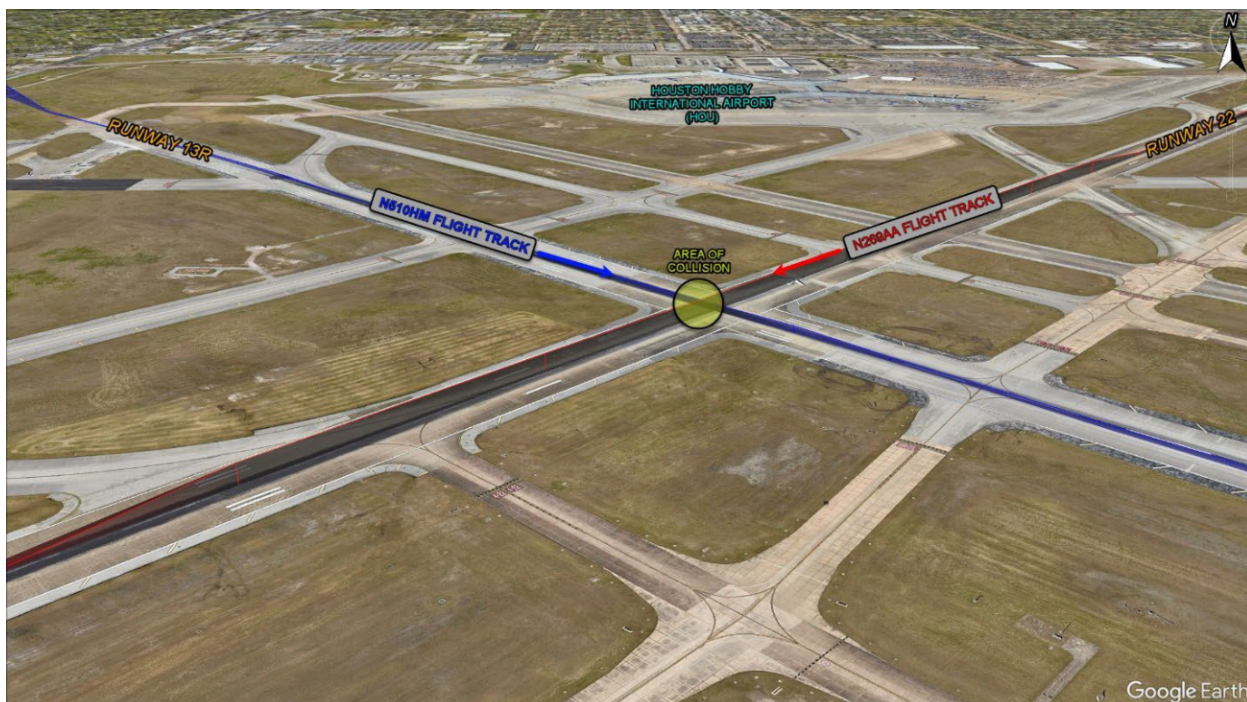
HOU has intersecting runways, and the local controller had instructed the crew of N269AA to line up and wait (LUAW) on runway 22. The crew of N269AA said in a post-accident interview that they believed they heard that they were cleared for takeoff when they took off. The collision between the two airplanes occurred at the intersection of the two runways, see figure 1.

**Figure 1.** View of both airplanes flight tracks with the area the ground collision occurred highlighted in yellow. The blue line represents N510HM, and the red line represents N269AA.

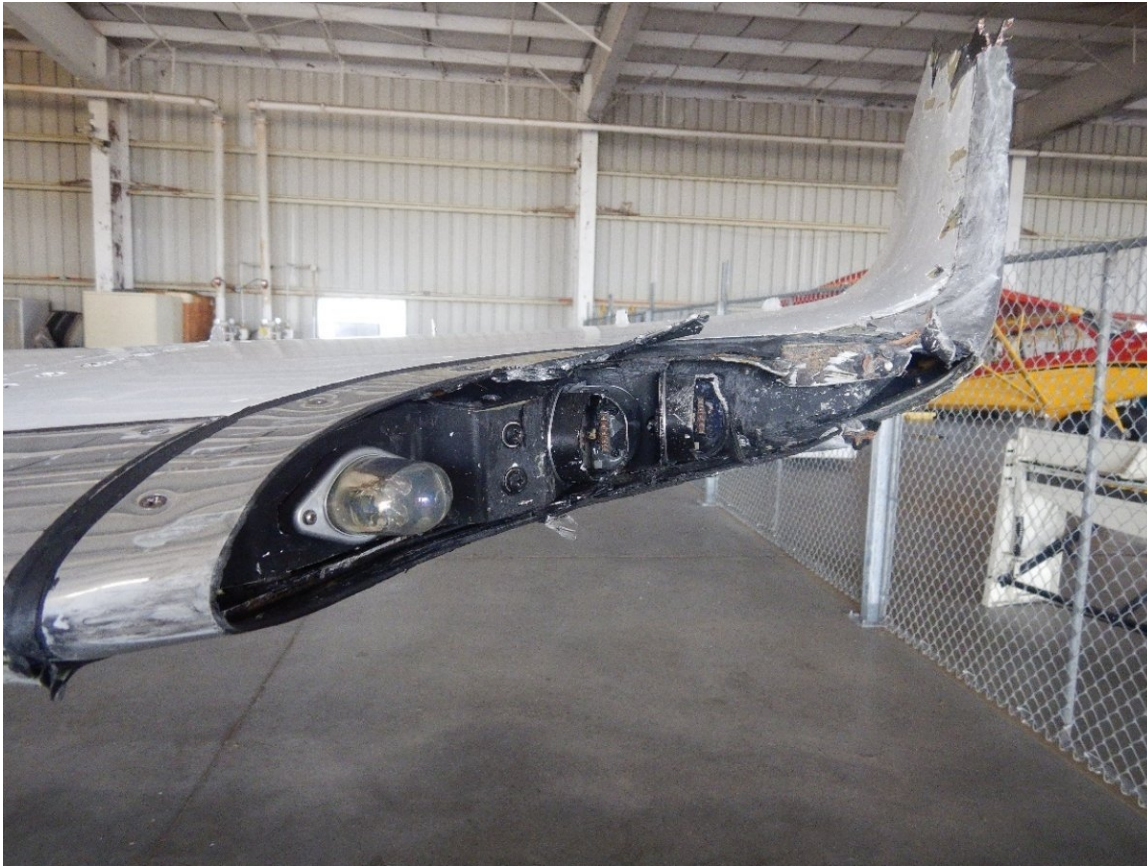
N269AA’s left-wing winglet remained attached to the left wing. The winglet leading edge exhibited white paint transfer marks and the navigation light lens was impact separated and pieces of the glass were found in the Cessna Mustang’s tail cone/stinger. About ten inches of

the top section of N269AA's winglet had separated due to the impact with N510HM, see figure 3.

**Figure 3.** Close up view of N269AA's left winglet/navigation light assembly damage.

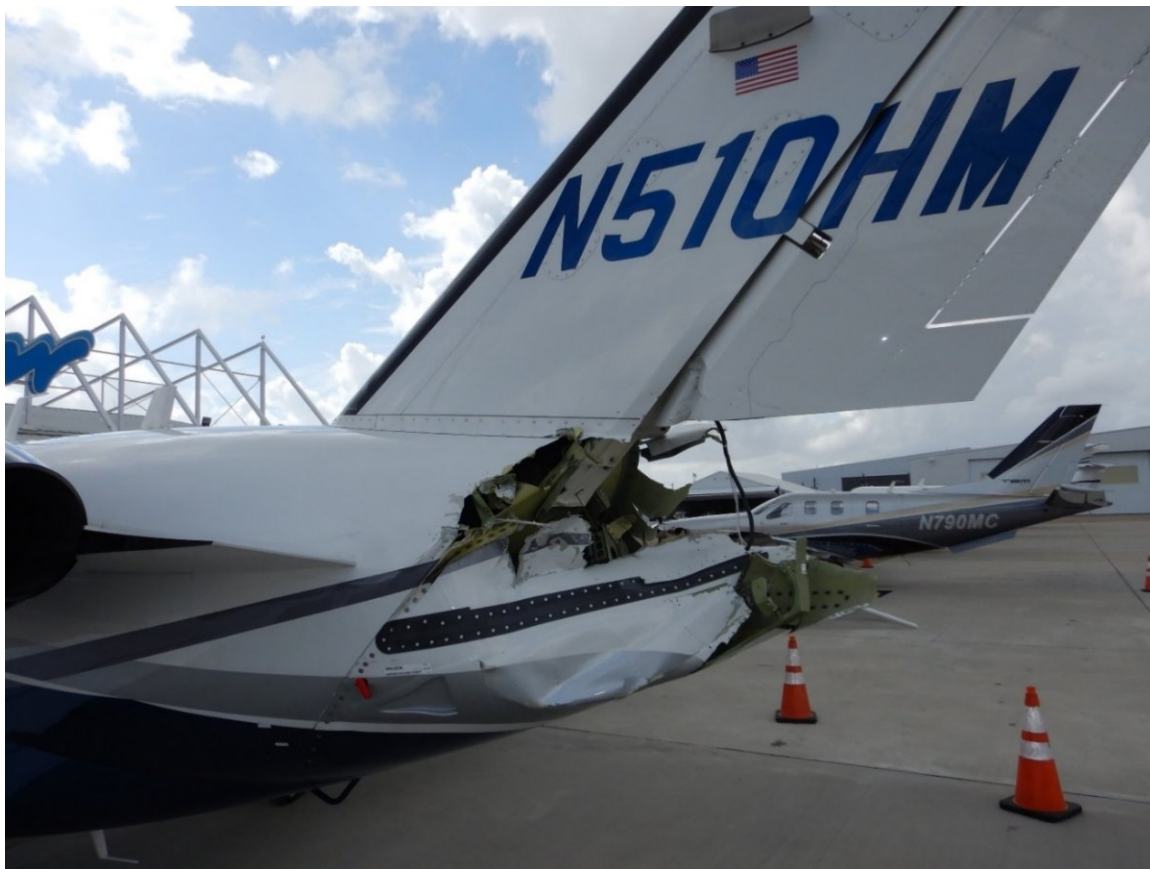
Post-crash examination of N510HM revealed that the left side of its tail section had been impacted by the left wing of N269AA. The torn skin on the tail section was consistent with N269AA's wing penetrating the left side of N510HM's tail stinger and exiting the right side, severing a portion of the stinger. The impact damage was isolated to the area of the empennage, see figures 4, 5 and 6.

The impact fractured and separated a section of the aft canted bulkhead. A section of the aft horizontal stabilizer spar; common to the rudder sector attach point, was torn and bent consistent with the wing impact. The rudder sector mount was torn from the structure at the fastener locations.

The rudder torque tube was fracture separated from the rudder control sector and the rudder. The upper and lower left and lower right rudder control cables were broken in a manner consistent with tensile overload. The upper right rudder control cable remained intact, but the ball end was pulled from the rudder sector. The autopilot rudder servo control cable was fractured in tensile overload. The left autopilot cable pulley bracket, with pulley attached, was separated from the canted bulkhead. The left strake was impact fractured from the tail cone stinger and was recovered from the runway along with various sheet metal fragments from the stinger.

**Figure 4.** Left side view of N510HM's damage to its empennage.
