# Advisory Wire

| REFERENCE NO: | AW700-33-0842 | INFORMATION TYPE: | Maintenance |
| ATA: | 33-41 | EFFECTIVITY: | Global 7500 |
| SUBJECT: | Wing Landing/Taxi Light Lens | | |

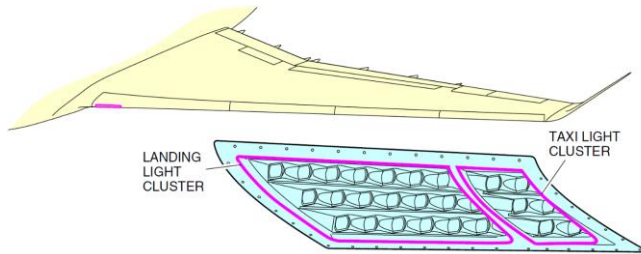
Figure 1: WLL assembly

The WLL assembly (Figure 1) includes two Light Emitting Diode (LED) light clusters where a polycarbonate lens is covering the assembly. This lens is held by an aluminum bezel (Figure 2) that is attached to the WLL assembly (Ref. 1.1).
